Service Bulletin

82-S0515

Room Slide Control Replacement (Installation Instructions)

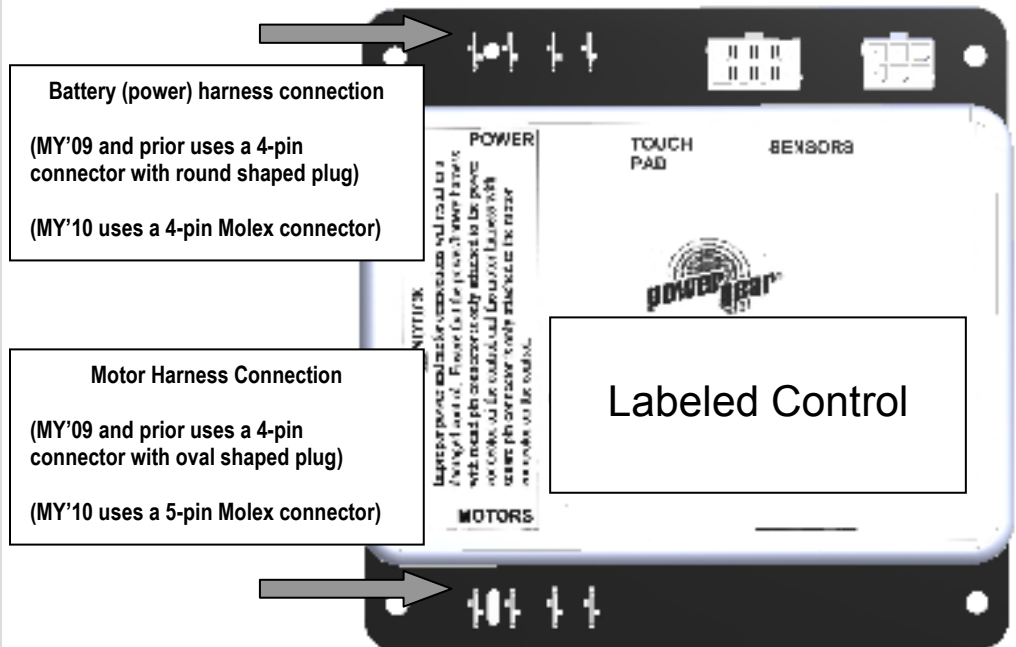
The battery (power) and motor harness receiving hole connection points (located between the 1st and 2nd blade connectors) are identified on the decal located on the control to ensure proper installation.

For ease of installation, and to ensure proper connection, replace one harness at a time.
