TIP SHEET

Upgrade Procedure for Room Locks 907100111 & 907100112

#82-S0519, Rev. 0F 6/12

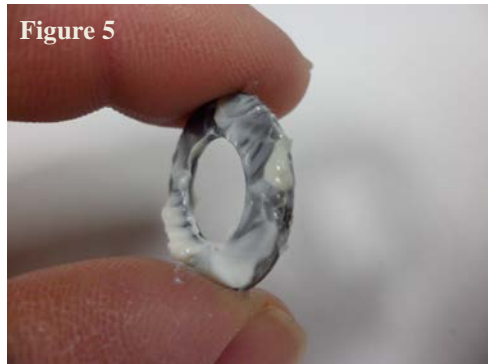
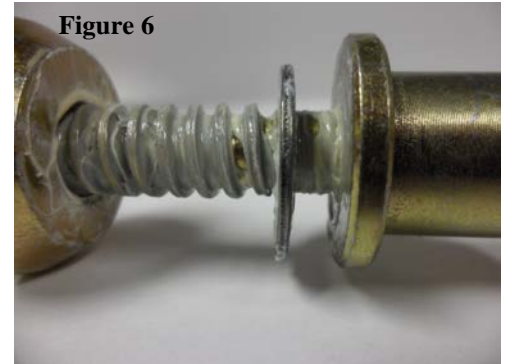
- 9) Lubricate both sides of Belleville washer (Part #2010000474) with Sta-Lube Multipurpose Super White Grease SL3151 (or equivalent), and install with curve toward flange of the acme screw (Figure 5, 6, and 7).

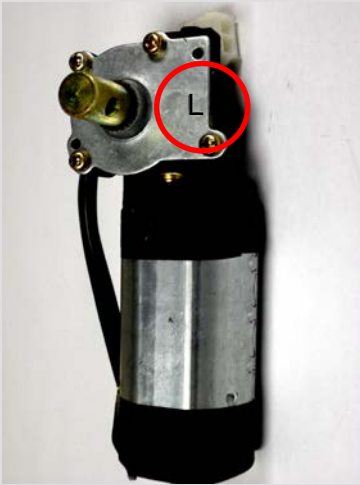
Motor #1820130

- 10) Reverse steps 2 thru 7 to re-assemble the room lock. You may have to turn the Acme screw or motor shaft to align the holes. **Make sure to use the new replacement motor during assembly.**
 For Left Hand Room Lock #907100111, use motor #1820131 (It will have "R" stamped into metal housing. See picture to the left).
NOTE: The motor "hand" position is opposite the assembly "hand" position.
 For Right Hand Room Lock #907100112, use motor #1820130 (It will have "L" stamped into metal housing. See picture to the left).
NOTE: The motor "hand" position is opposite the assembly "hand" position.
- 11) Verify operation of assembly by extending & retracting lock assembly several times.
- 12) Test slide out room to make sure it moves out and in. If the room does not operate, check and adjust the two limit switches on the room lock.
- 13) Re-install access panels as required.
