**SLIDE-OUTS**

# INNER TUBE ASSEMBLY REVISION ON THROUGH FRAME SLIDE-OUTS

TI-184

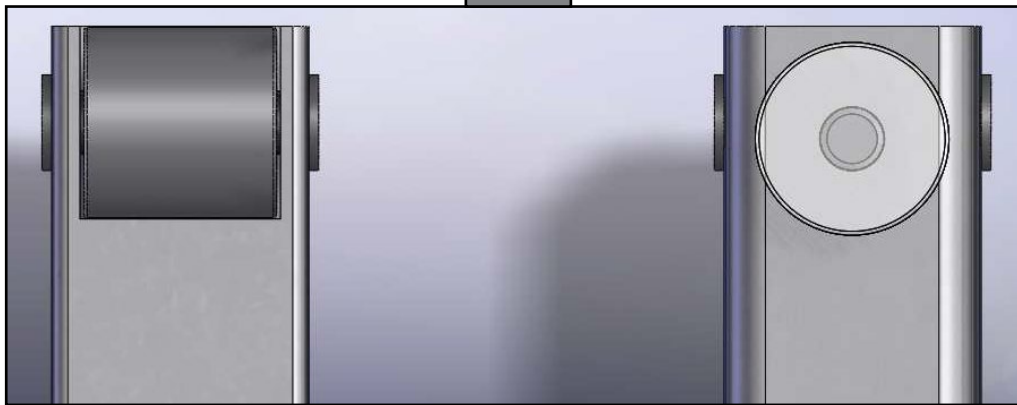
**Fig. 1**

Old version with Rear Roller ([104475](#)), Roller Shaft ([105893](#)), and Inner Tube Assembly (See Page 2)

New version with Wear Tab ([277882](#)) and Inner Tube Assembly (See Page 2)

Top View

A revision has been made to the Inner Tube Assembly on Through Frame Slide-outs. The Rear Roller ([104475](#)) and Roller Shaft ([105893](#)) have been removed and replaced with a Wear Tab ([277882](#)). These new Inner Tube Assemblies are 100% interchangeable with the former design. This change was made to reduce noise created by the Rear Roller. See the illustrations below. See Page 2 for a part number comparison chart between the old version and new version.

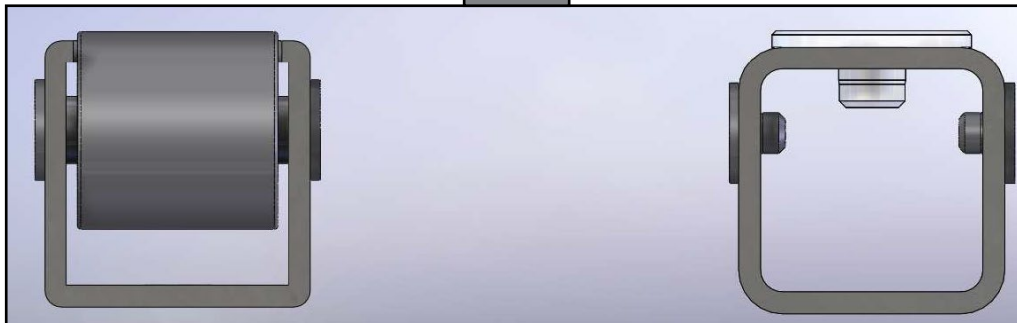
**Fig. 2**

Front View

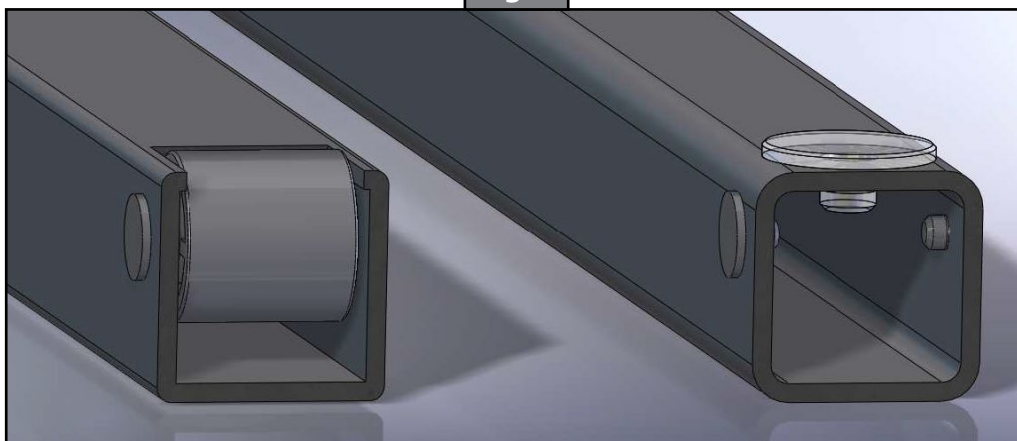
**Fig. 3**

Isometric View
